Rebuilding Christchurch

*An earthquake-proof
HVAC retrofit*

REBUILDING CHRISTCHURCH

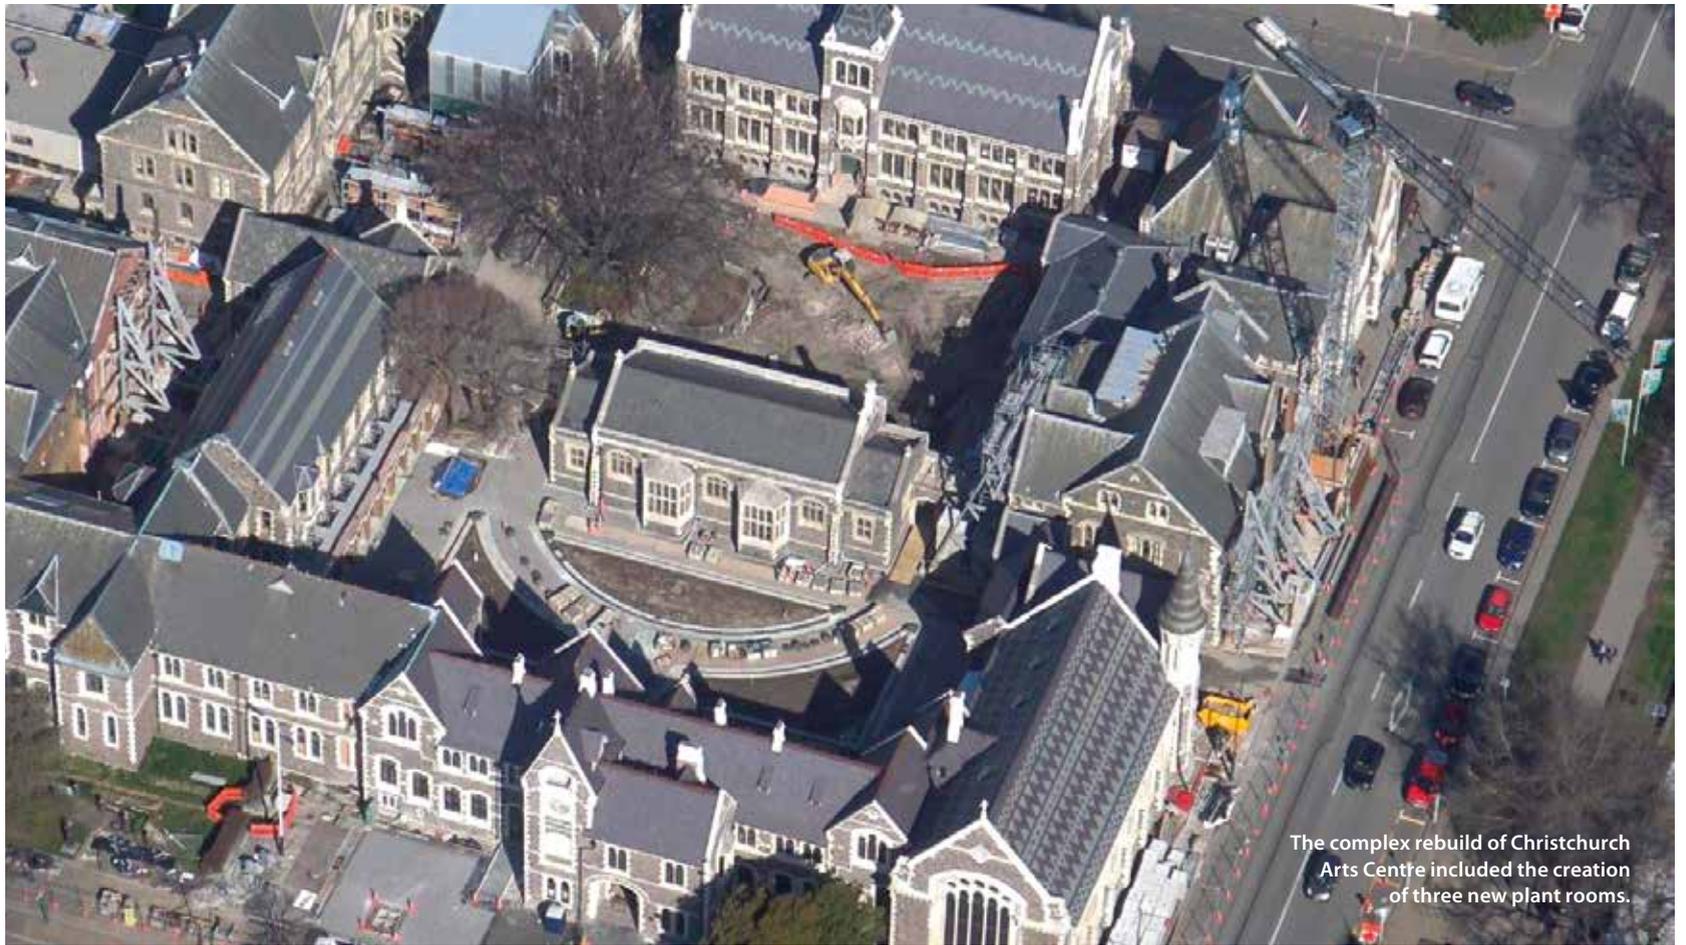
The complex rebuild of Christchurch Arts Centre included the creation of three new plant rooms.

Benmax Group created three new plant rooms – one in the basement area of the heritage-listed Library building, another below the Workshop building, and a third in the existing Chemistry building.

The Library plant room was designed to serve the site's C Block, which includes the Great Hall and Chemistry buildings, while the new Workshop plantroom serves a number of other buildings as well as providing redundancy to the main Library plantroom.

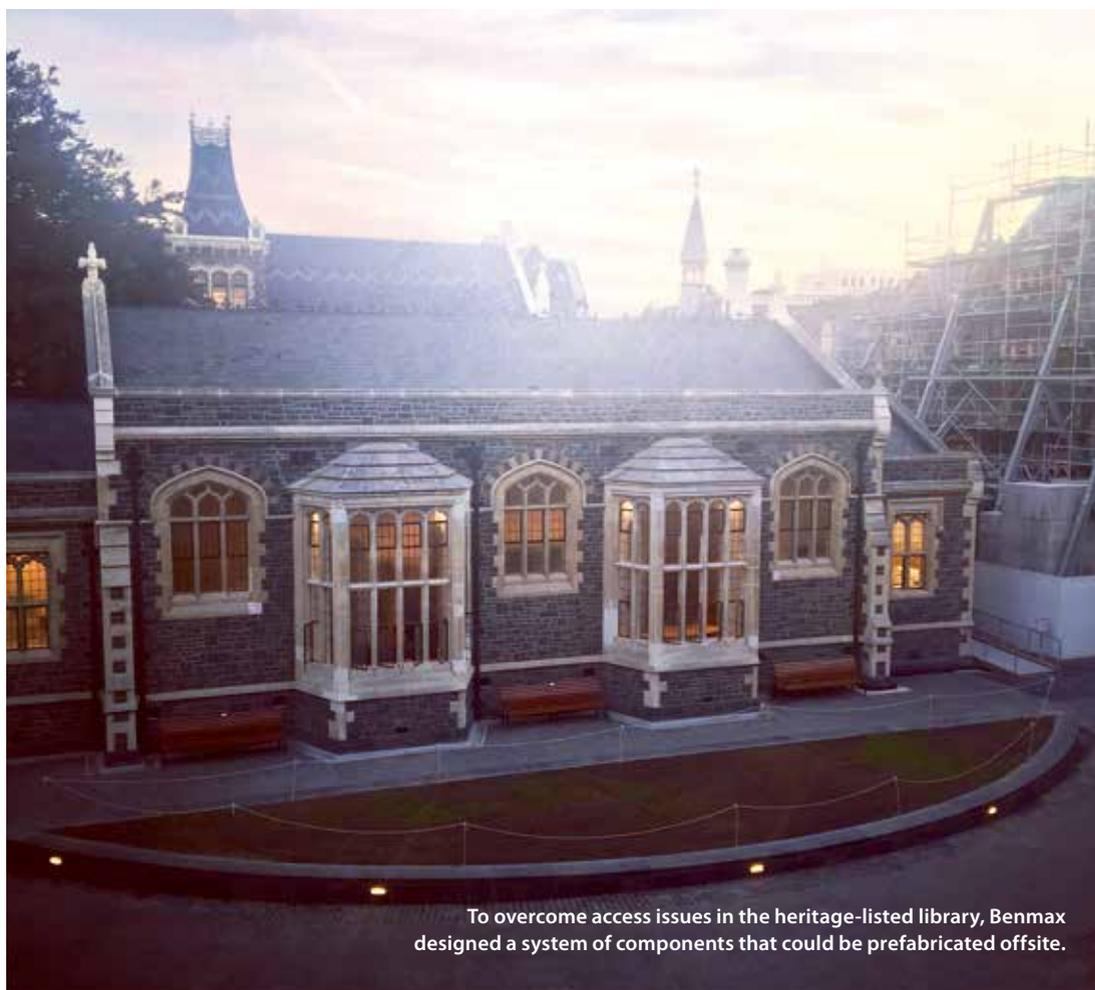
To overcome access issues in the heritage-listed library, Benmax designed a system of components that could be prefabricated offsite.

To overcome these issues, Benmax designed a system of components that could be prefabricated offsite. It commissioned the Victaulic construction piping services (CPS) department to assist with the design, and provide detailed spool drawings, which were used in the prefabrication of the pipework.

broke down the schematics into smaller, segmented spools that were small enough to meet the space restrictions of the site.

A size limit of 3m was placed on each length to ensure it could be taken down the staircase, before fitting together like a Meccano set.

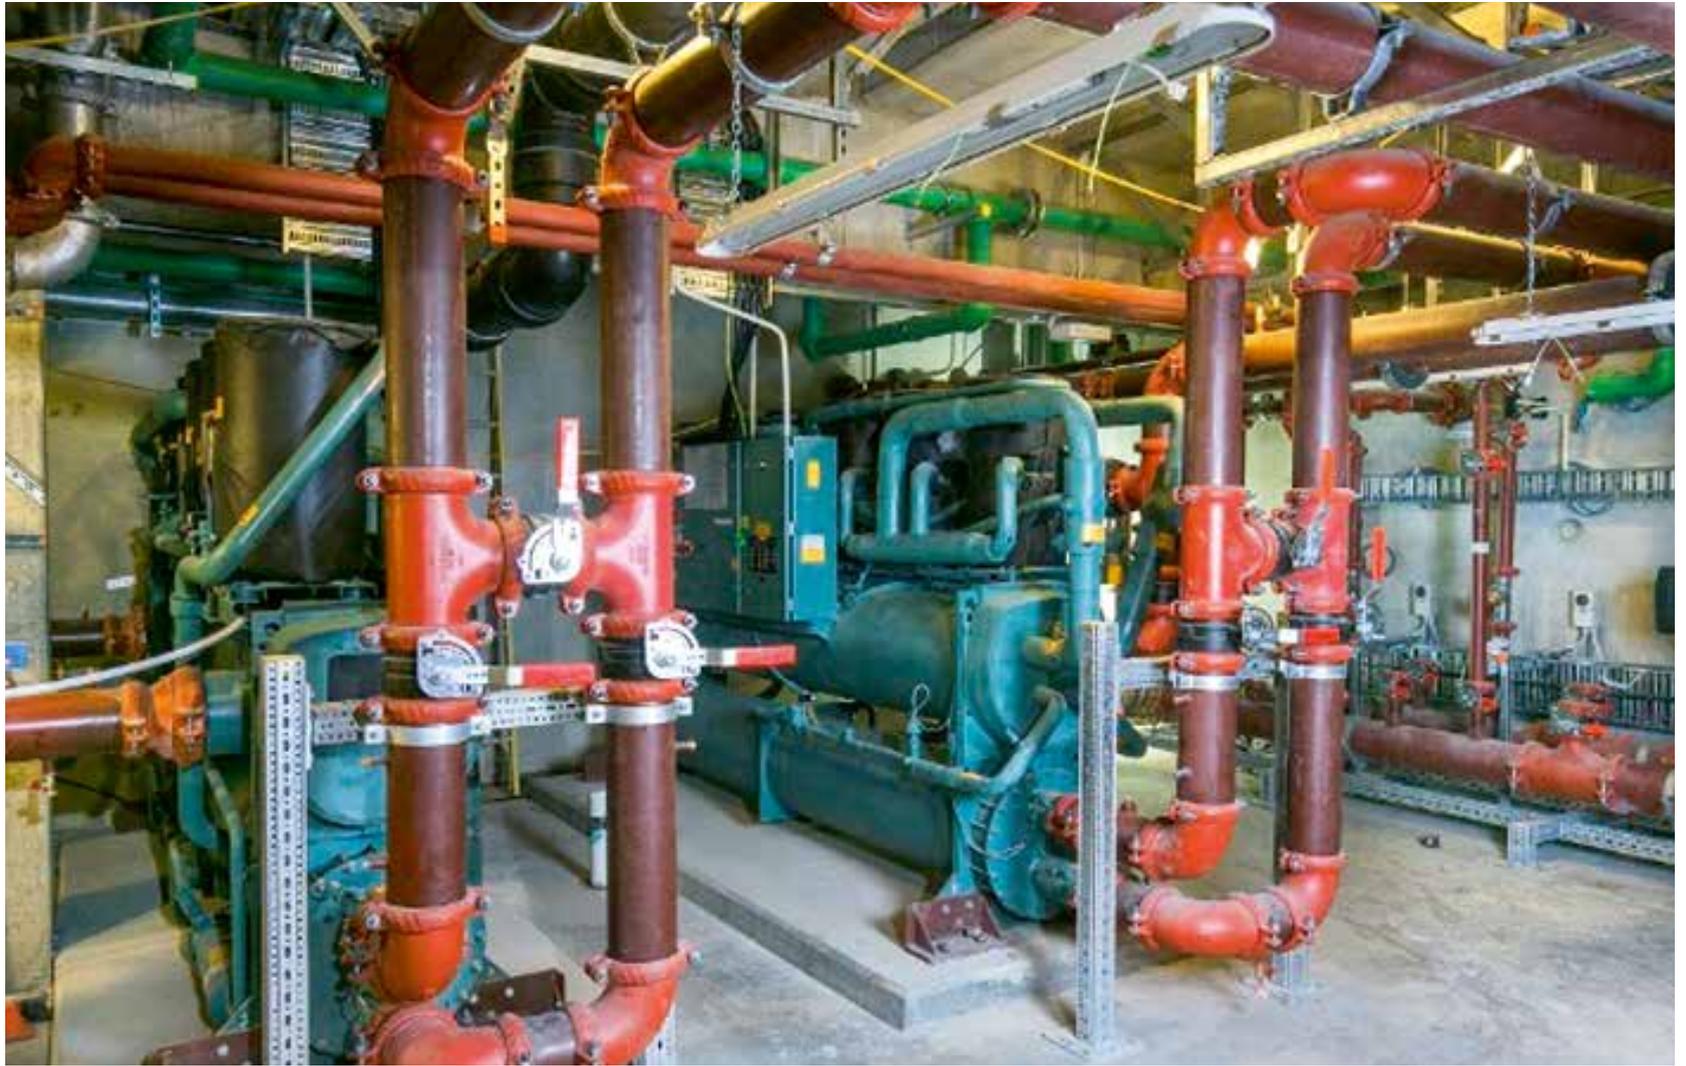
“In Australia, 63mm fusiotherm pipe would require just a straight hanger, enabling you to deal with everything in the same plane as the pipe and parallel with the pipe. But what you need to do here [in Christchurch] is install brackets at 45 degrees for anything 200mm or more off the ceiling.

“So it means that if you are 600mm off the ceiling, for example, you are also 600mm out on each side of the pipework, creating a large V-shape. This impacts on access, future access and maintenance and has implications for other services because they also require the same fixing.”
